Seismic Assessment for Restoration of Prambanan World Heritage Temples Damaged by the Central Java Earthquake of 2006, Indonesia

July 6th, 2010 at Hilton Hotel

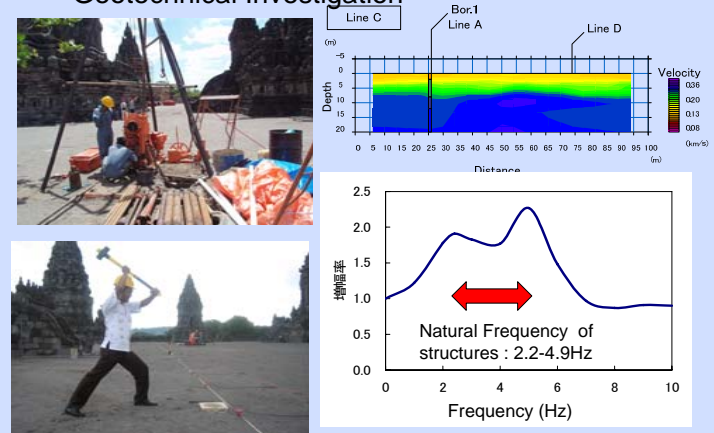
2. Geotechnical and Structural Survey Geotechnical Investigation

- Are the soils that support the Prambanan temples natural deposits or man-made embankment ?
- The geotechnical investigation indicates that the soils are natural ones and differential settlement of foundation was not caused by the seismic response to the Central Java Earthquake.

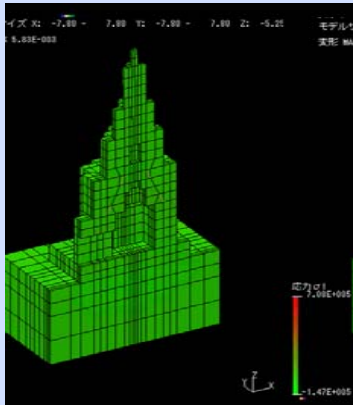
3. Seismic Response Analysis Simulation – input motion : Athens EQ of 1999

Input level :
PGV=12.4cm/s
PGA=0.217G

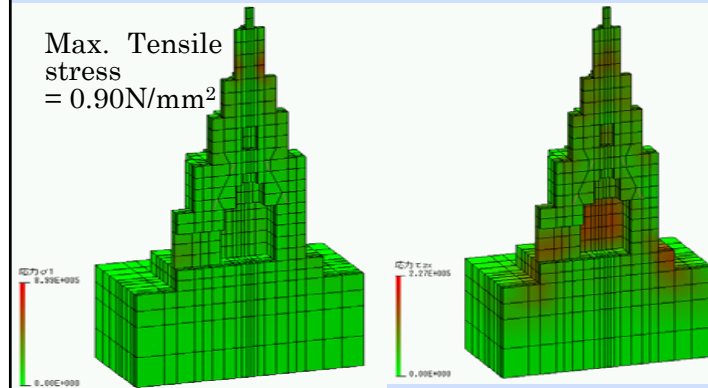
3. Seismic Response Analysis Analysis Results - Stress in Stone and Rubble

Max. Tensile stress
= 0.90N/mm²

Principal Stress

Shear Stress
